(NASA-CR-174411) CREEP-RUPTURE BEHAVIOR OF
IRON SUPERALLOYS IN HIGH-PRESSURE HYDROGEN
Quarterly Narrative Report, 7 Dec. 1982 - 28
Feb. 1983 (IIT Research Inst.) 44 p
HC A03/MF A01

CREEP-RUPTURE BEHAVIOR OF IRON SUPERALLOYS
IN HIGH-PRESSURE HYDROGEN

First Quarterly Narrative Report
for Period Covering 7 December 1982 to 28 February 1983

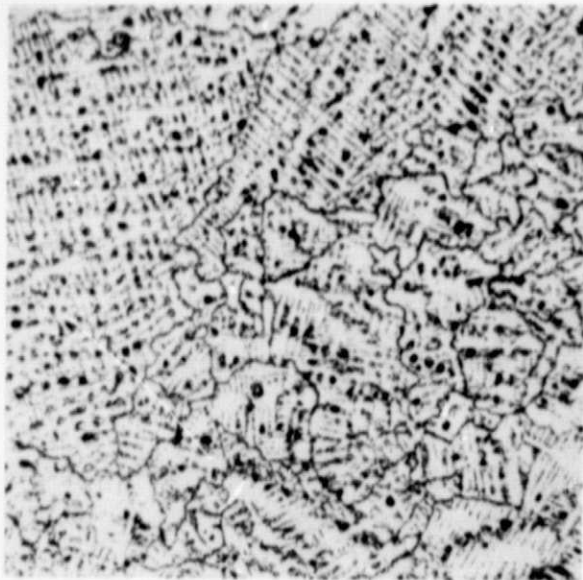
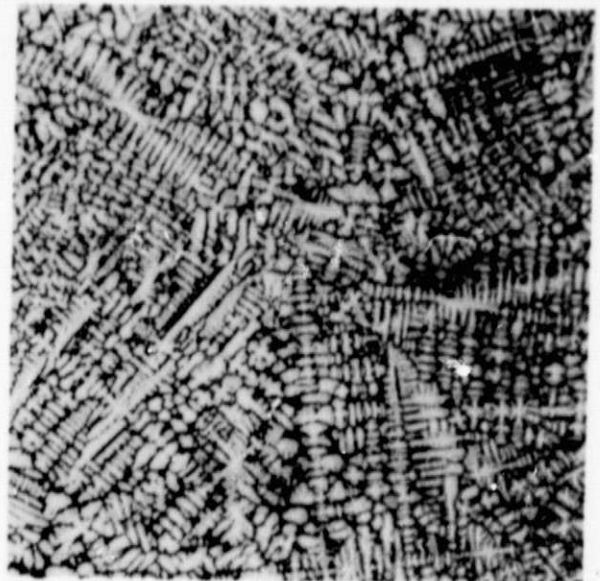
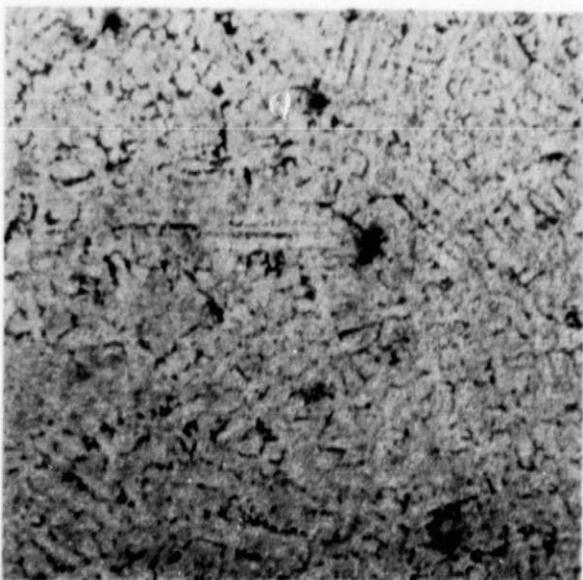
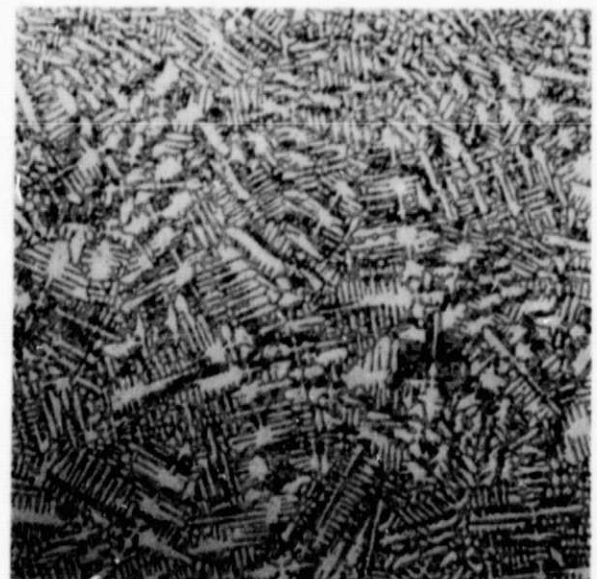
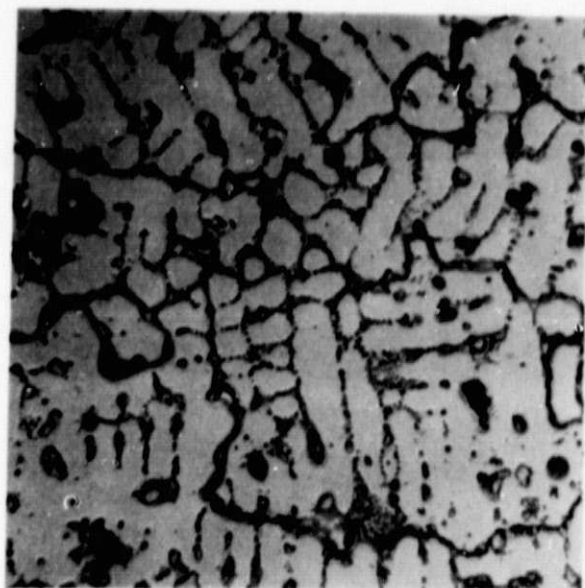
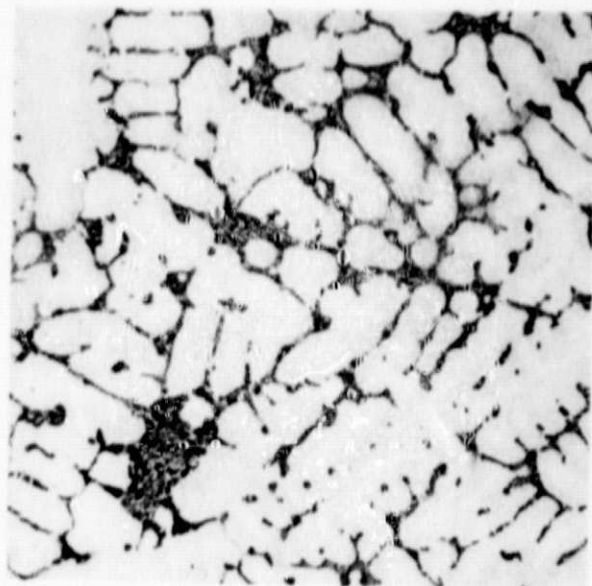
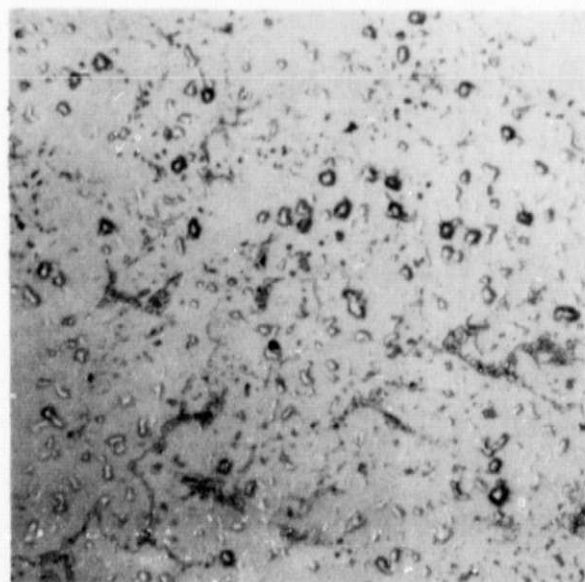
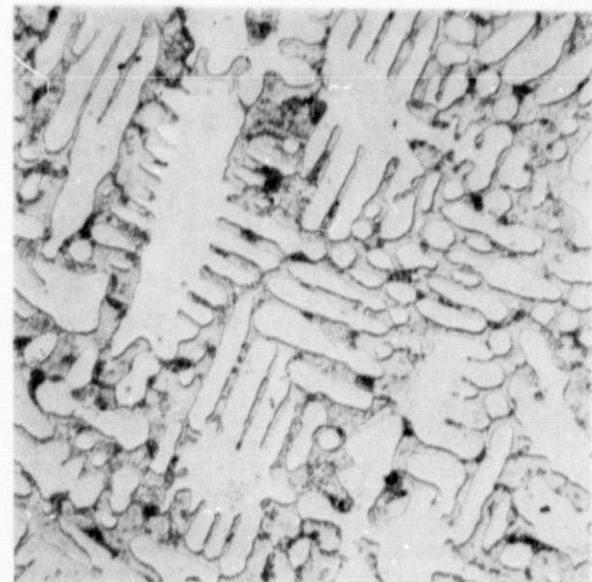
Figure 3. Microstructure of cast alloys heat treated in 10^{-6} mm vacuum at 1150°C (2100°F) for 1 h and furnace cooled. (a,e) XF-818, (b,f) CRM-6D, (c,g) HS-31, (d,h) SA-F11. Electrolytically etched in 10% oxalic acid.

All the six alloys have solid solution-strengthened austenitic structures with varying amounts of precipitates depending on carbon, boron, and nitrogen levels, type of processing (cast vs. wrought), and heat treatment. Typical microstructures of the four cast alloys and the two sheet alloys are shown in Figs. 3 and 4.

In Figs. 3a to d, at 50X, the typical dendritic structures of the cast alloys are clearly revealed. The interdendritic arm spacings are very similar, with HS31, probably showing a little coarser spacing. The grain pattern shown in Fig. 3a for XF-818 is not seen in the other cast alloys. The dendrite arms and grain boundaries usually consist of boride- and carbide-containing constituents, and the lower carbon and chromium contents of XF-818 are reflected in its lower hardness.

In Figs. 3e to h, the microstructures of the four cast alloys are shown at a higher magnification of 200X. The structures clearly indicate the discrete precipitates constituting the dendrite walls, and some coring effect is noted in CRM-6D. In HS-31, the structural continuity at the boundaries is much less in evidence and only traces of lamellar structure are noted.

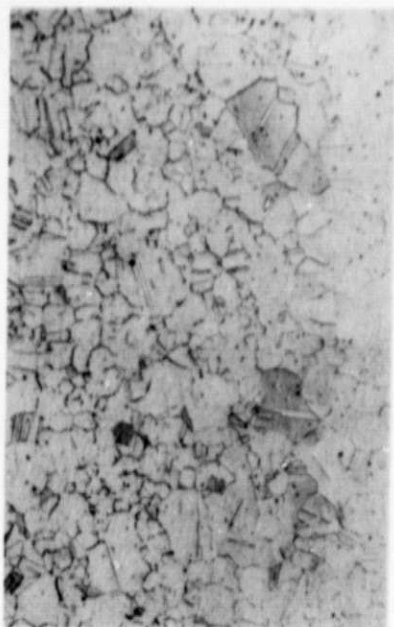
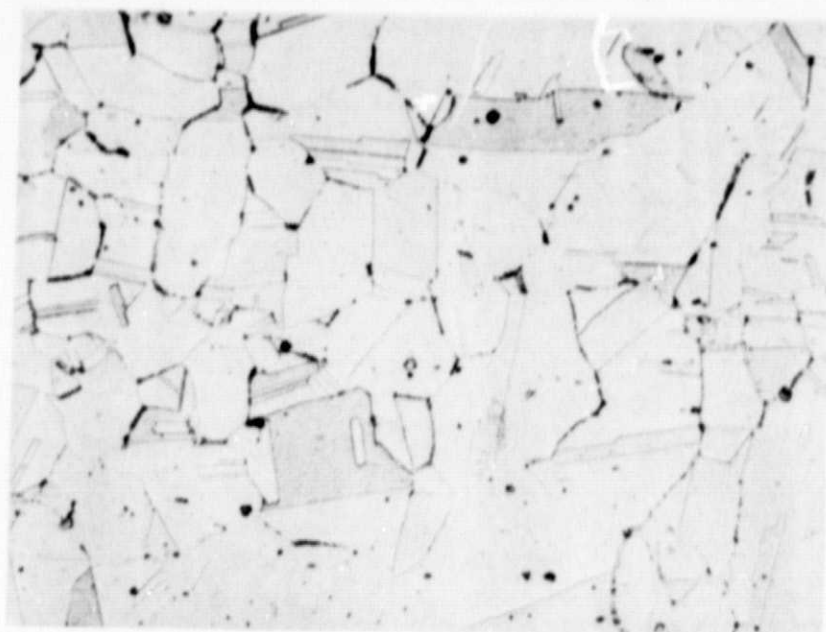
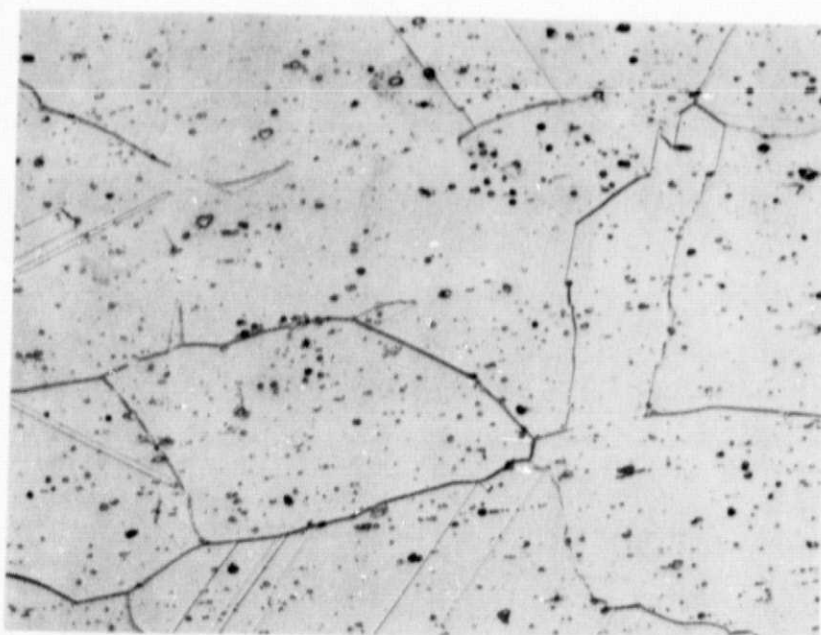
Figure 4. Microstructure of wrought alloys. (a,b) 12RN72, solution-annealed at 1150°C (2100°F) for 15 min and fast cooled; (c) CG-27, solution-annealed at 1150°C (2100°F) in 10^{-6} mm vacuum for 16 h, cooled to 650°C (1200°F), held for 24 h and furnace cooled. Electrolytically etched in 10% oxalic acid.

Figure 4 shows the wrought alloy structures for 12RN72 and CG-27. CG-27 has more than three times the hardness (and strength) of 12RN72 at room temperature and contains Al, Ti, Cb, Ta, and Mo in quantities significantly larger than 12RN72. CG-27 alloy contains low boron and carbon. While the literature data indicate a low level of boron in 12RN72, the analysis supplied by NASA did not show that. It is possible that B at 0.006% level is present in the alloys, and this may be checked by NASA.

In the solution-treated condition (Figs. 4a and b) the 12RN72 has a fully austenitic twinned structure with some undissolved particles, identified in Sandvik literature¹ as micron-sized carbides and nitrides of type TiN.

The solution-treated and aged structure of CG-27, shown in Fig. 4c, reveals fully austenitic grains with some fine precipitates related to its Ti and Al contents. Twinning is also evident but to a much lesser degree than 12RN72. CG-27 grain size is over three times larger than 12RN72.

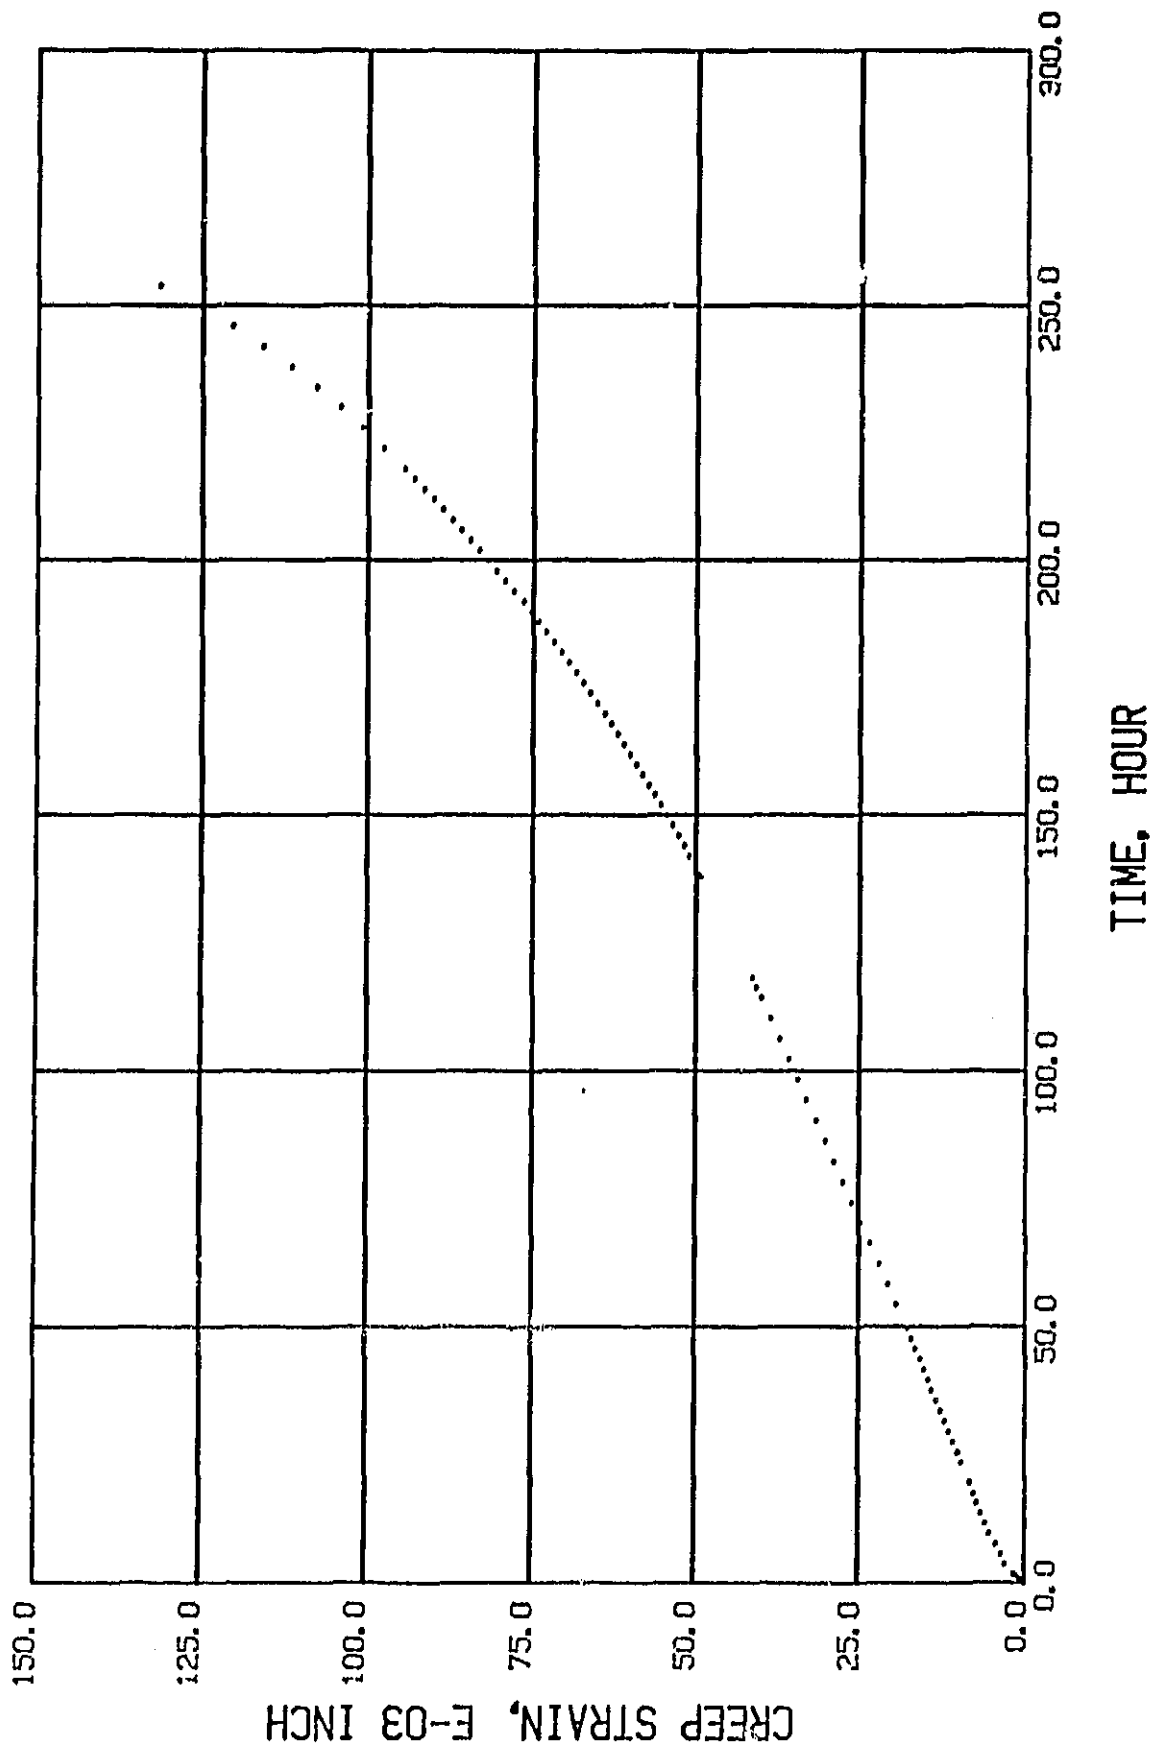
TEST H13 XF-818 760C./195MPa 15MPa H2

Figure 6. Creep strain-time curve for XF-818 tested at 760°C in 15 MPa H₂ (rupture life, 258 h).

With the help of scale magnification, it is possible to obtain the time-strain plots to reveal details which will be difficult to obtain otherwise. Generally, after the first 1 or 1-1/2 h, the data collection is done every 4 h and, for test durations of 200 to 1000 h, a frequency of 4 h reveals the information within the desirable accuracy. A comparison of different scale magnifications through computer is shown for HS-31 data from test H14 in Figs. 15, 16, and 17. From Fig. 15, one can obtain the specific times to 0.1, 0.2, 0.5, 1.0, and 2.0% creep strains; Figs. 16 and 17 both permit a measure of the minimum creep rate, while Fig. 17 permits an accurate measure of the time to onset of tertiary creep. The plateau in Fig. 17 indicates the limiting range of the transducer where it got stuck and then jumped to a higher value on fracture. A careful examination of all the figures indicates that a fracture event has no effect on the creep behavior of the rest of the specimens (compare Figs. 6, 8, 10, and 12 for test H13, and Figs. 7, 9, 11, 13, and 14 for test H14).

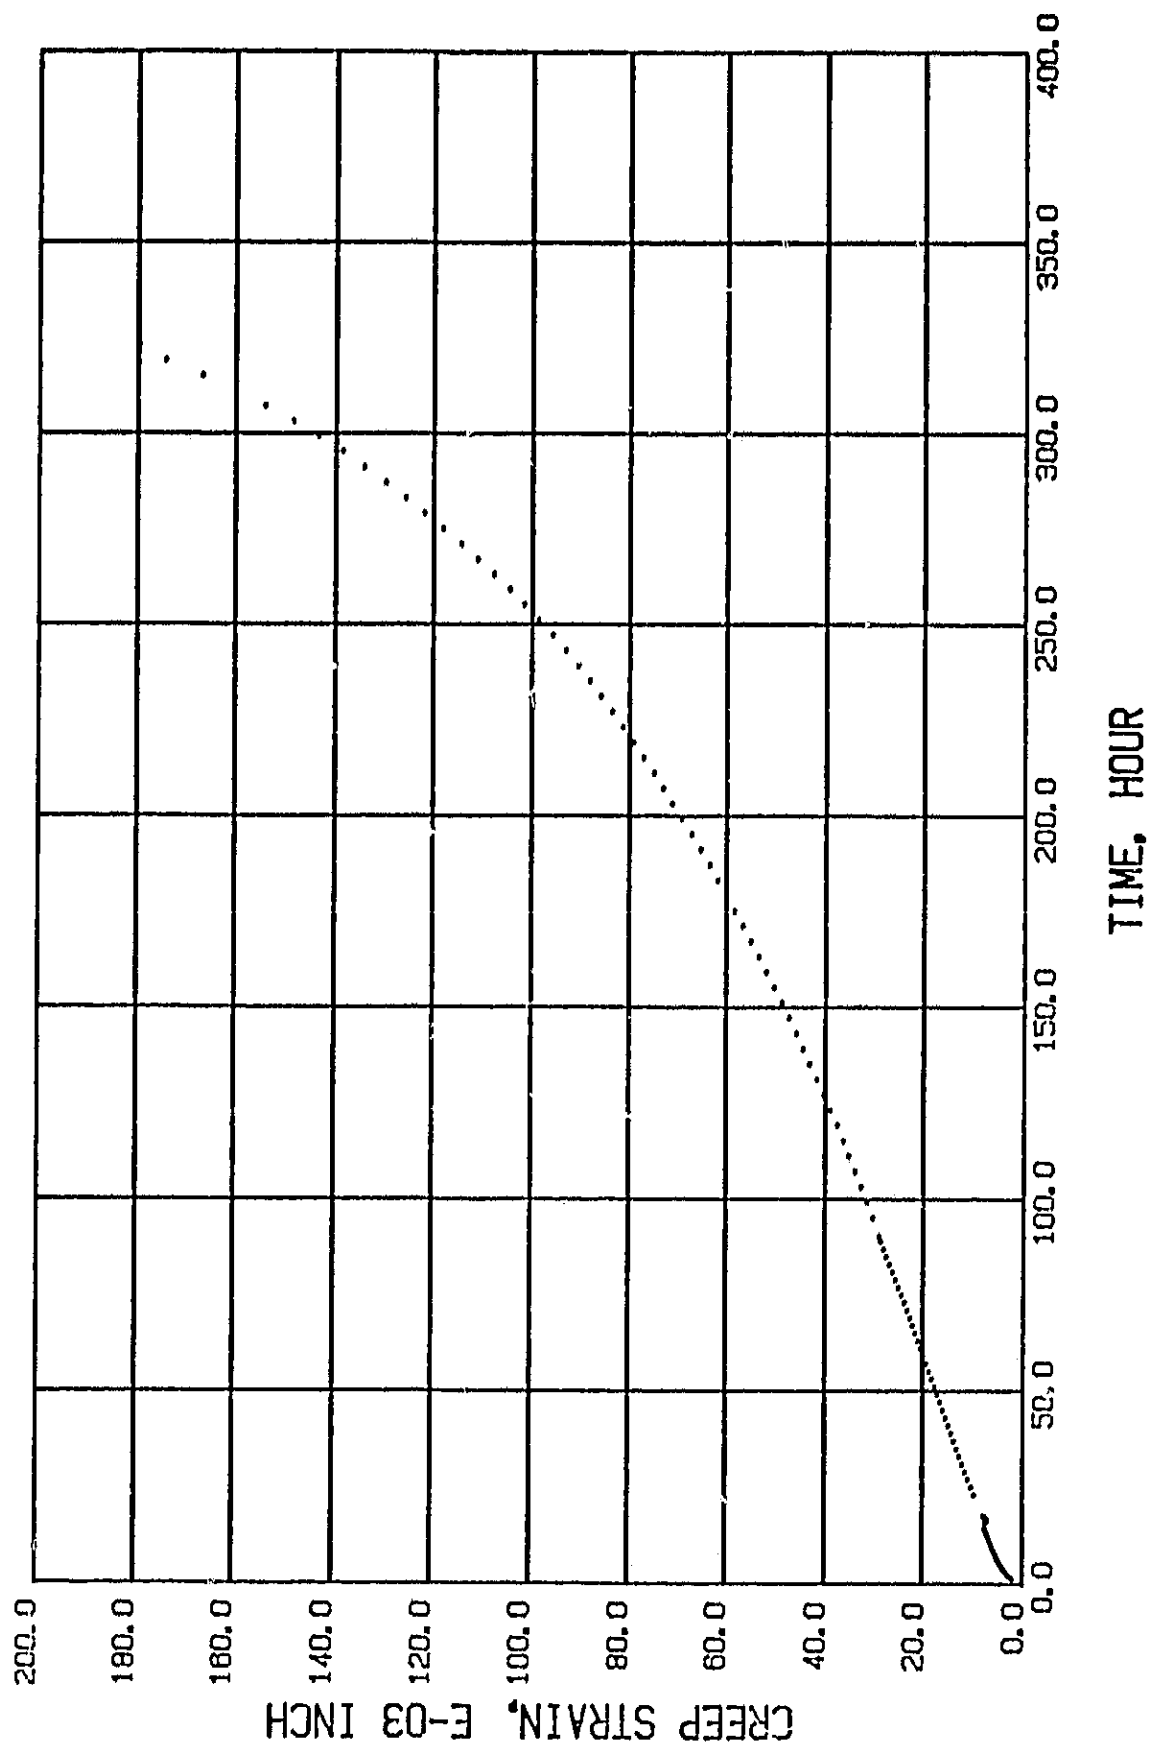
TEST H14 XF-818 760C./185MPa 15MPa H2

Figure 7. Creep strain-time curve for XF-818 tested at 760°C in 15 MPa H₂ (rupture life, 325 h).

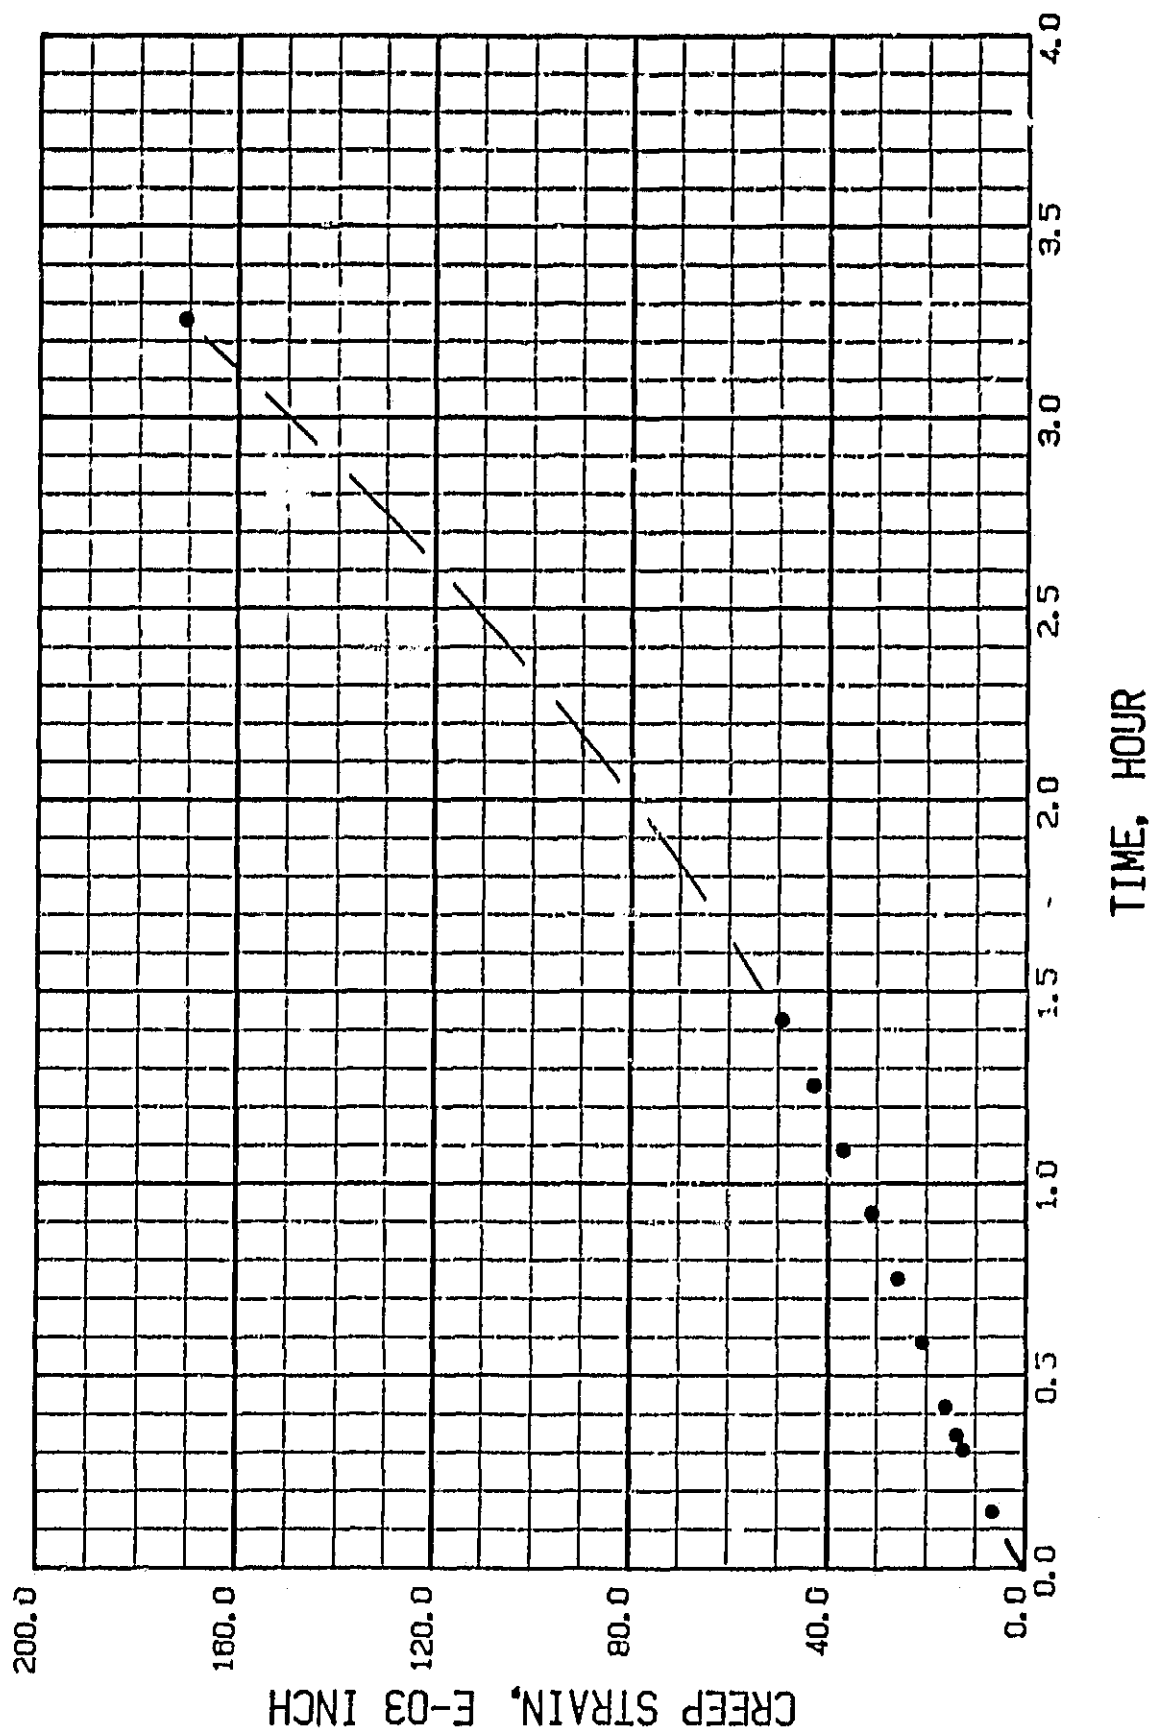
TEST H13 CRM-6D 760C./255MPa 15 MPa H₂

Figure 8. Creep strain-time curve for CRM-6D tested at 760°C in 15 MPa H₂ (rupture life, 3.7 h).
Missing portion of data shown with a dashed curve.

CRM-6D, because of high stress and short rupture life, exhibited a significant ductility of 20.1% elongation and 35.0% reduction in area. Shortly before rupture, at 3.3 h ($t_r = 3.7$ h), the observed creep extension was 11.9% (Fig. 8). It is obvious that significant elongation took place on fracturing to give a total elongation of 20.1%. Fracture observations on all four cast alloys are summarized in Table 8.

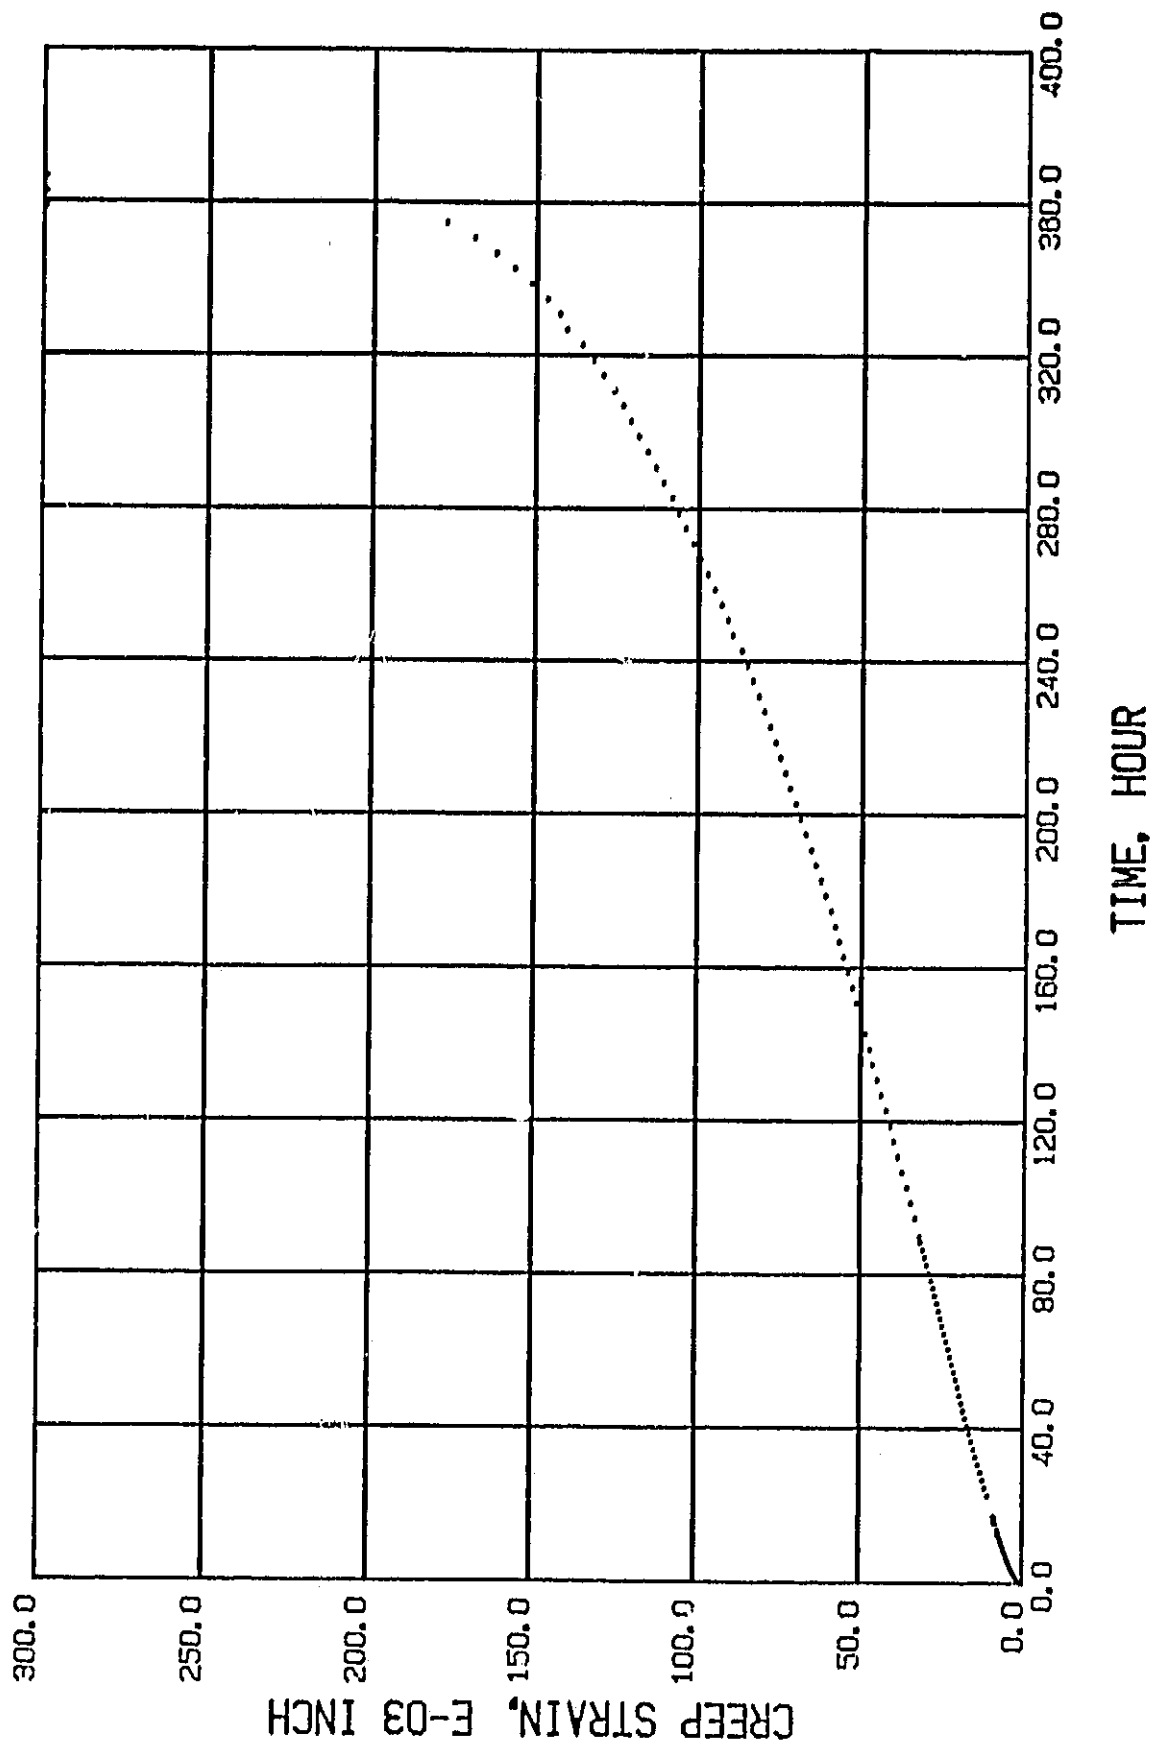
TEST H14 CRM-6D 760C./130MPa 15MPa H2

Figure 9. Creep strain-time curve for CRM-6D tested at 760°C in 15 MPa H₂ (rupture life, 357 h).

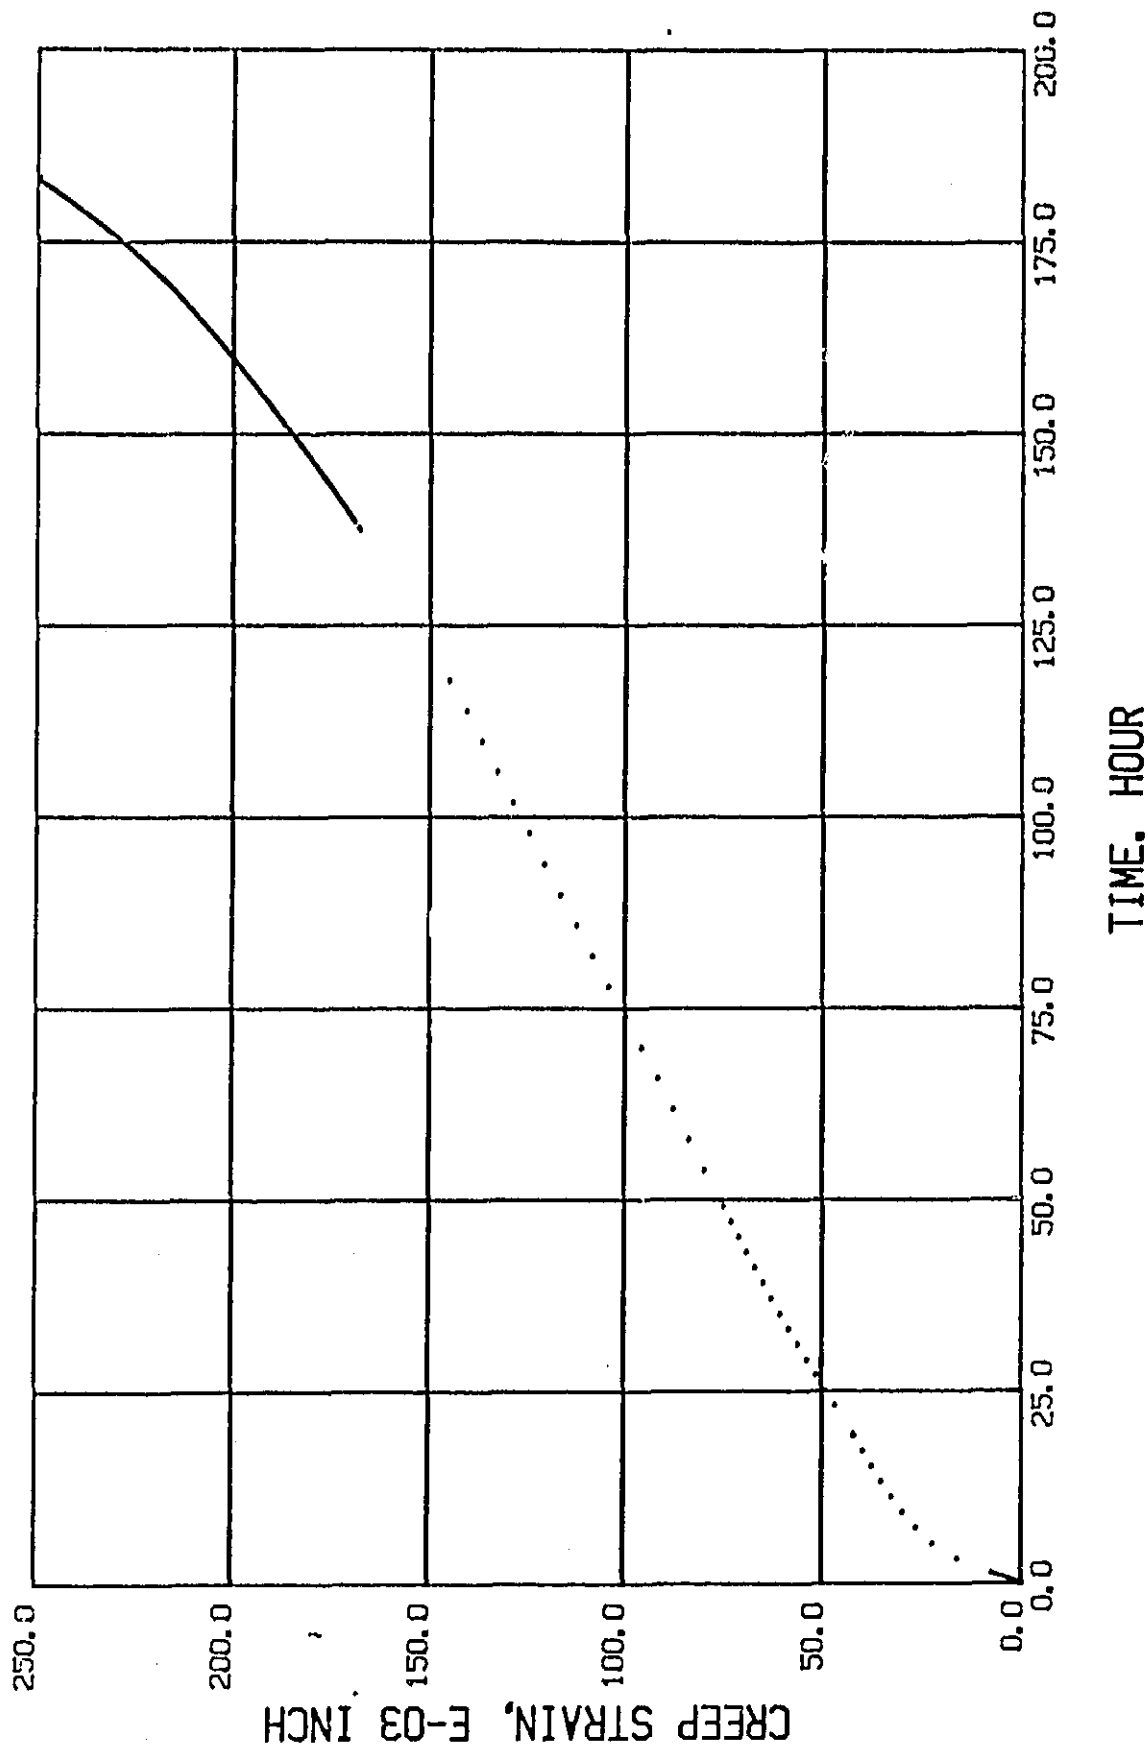
TEST H13 HS-31 760C./245MPa 15MPa H₂

Figure 10. Creep strain-time curve for HS-31 tested at 760°C in 15 MPa H₂ (rupture life, 193 h).

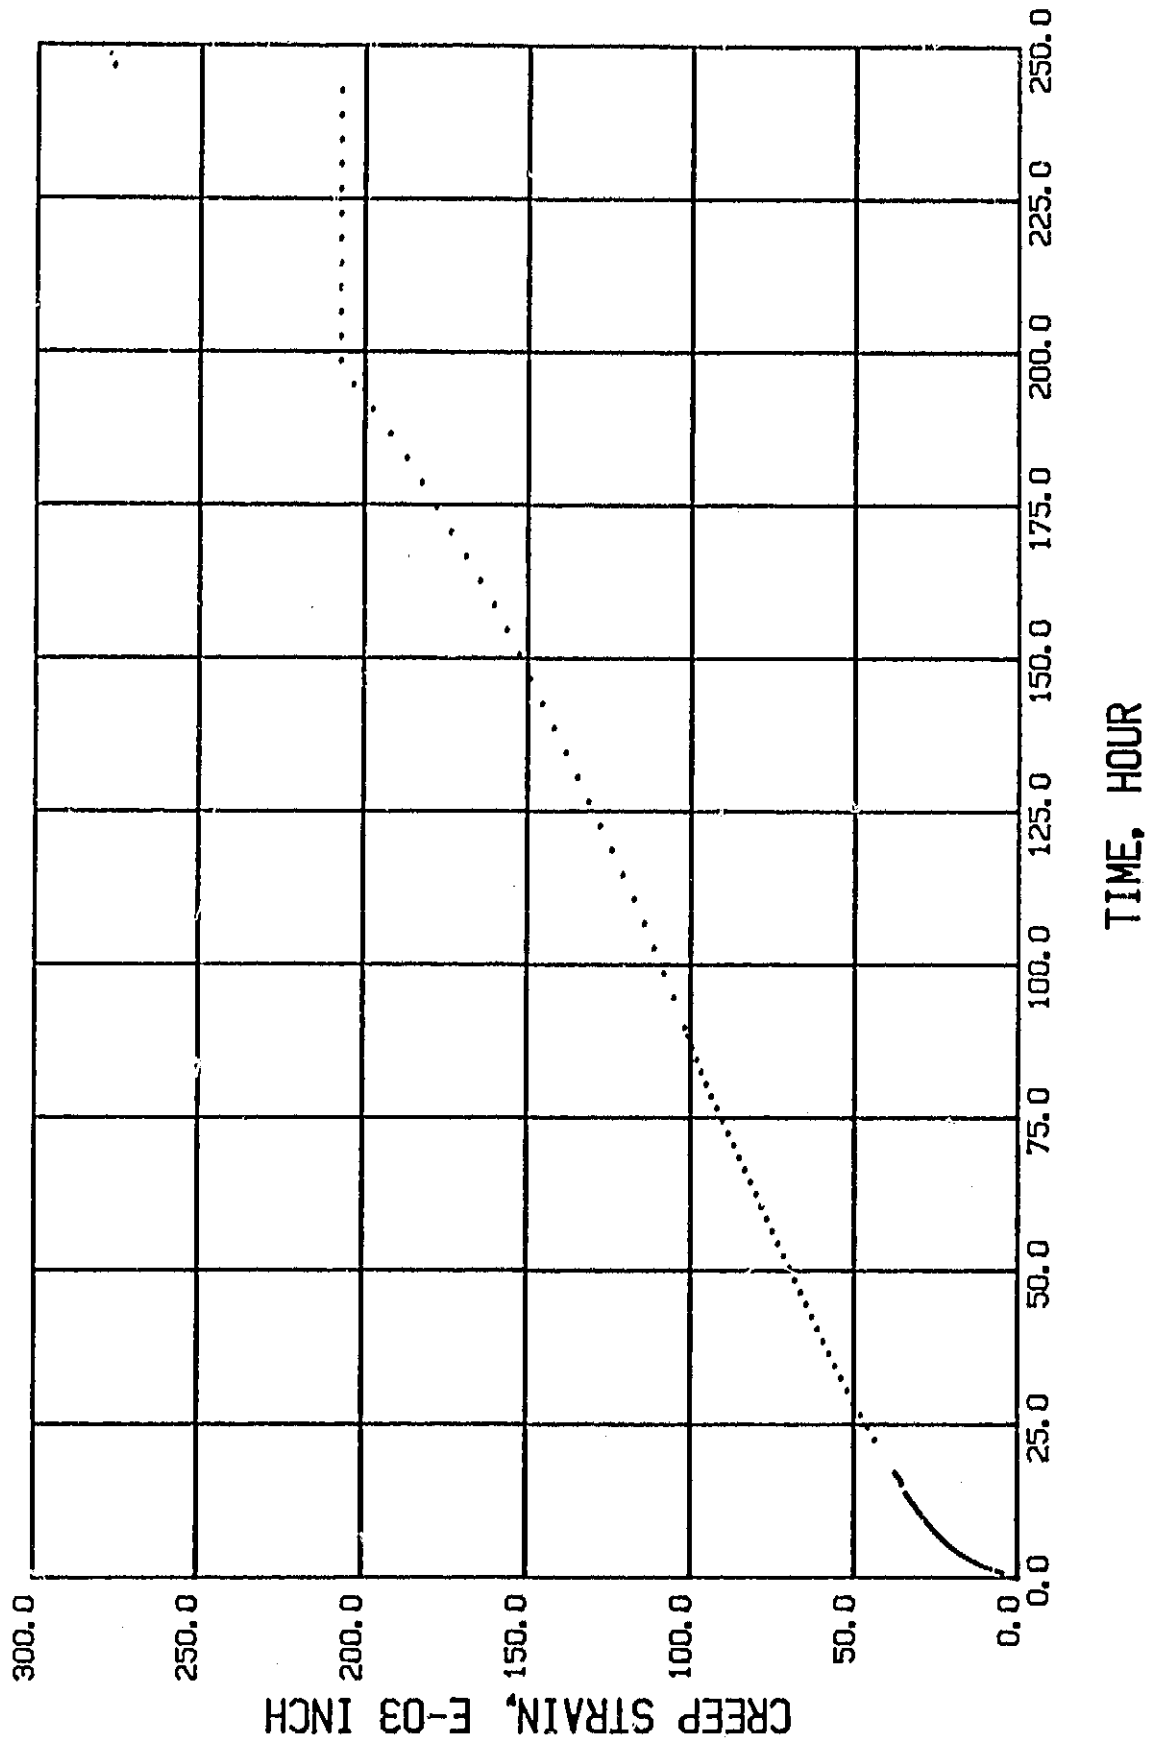
TEST H14 HS-31 760C./235MPa 15MPa H2

Figure 11. Creep strain-time curve for HS-31 tested at 760°C in 15 MPa H₂ (rupture life, 245 h).

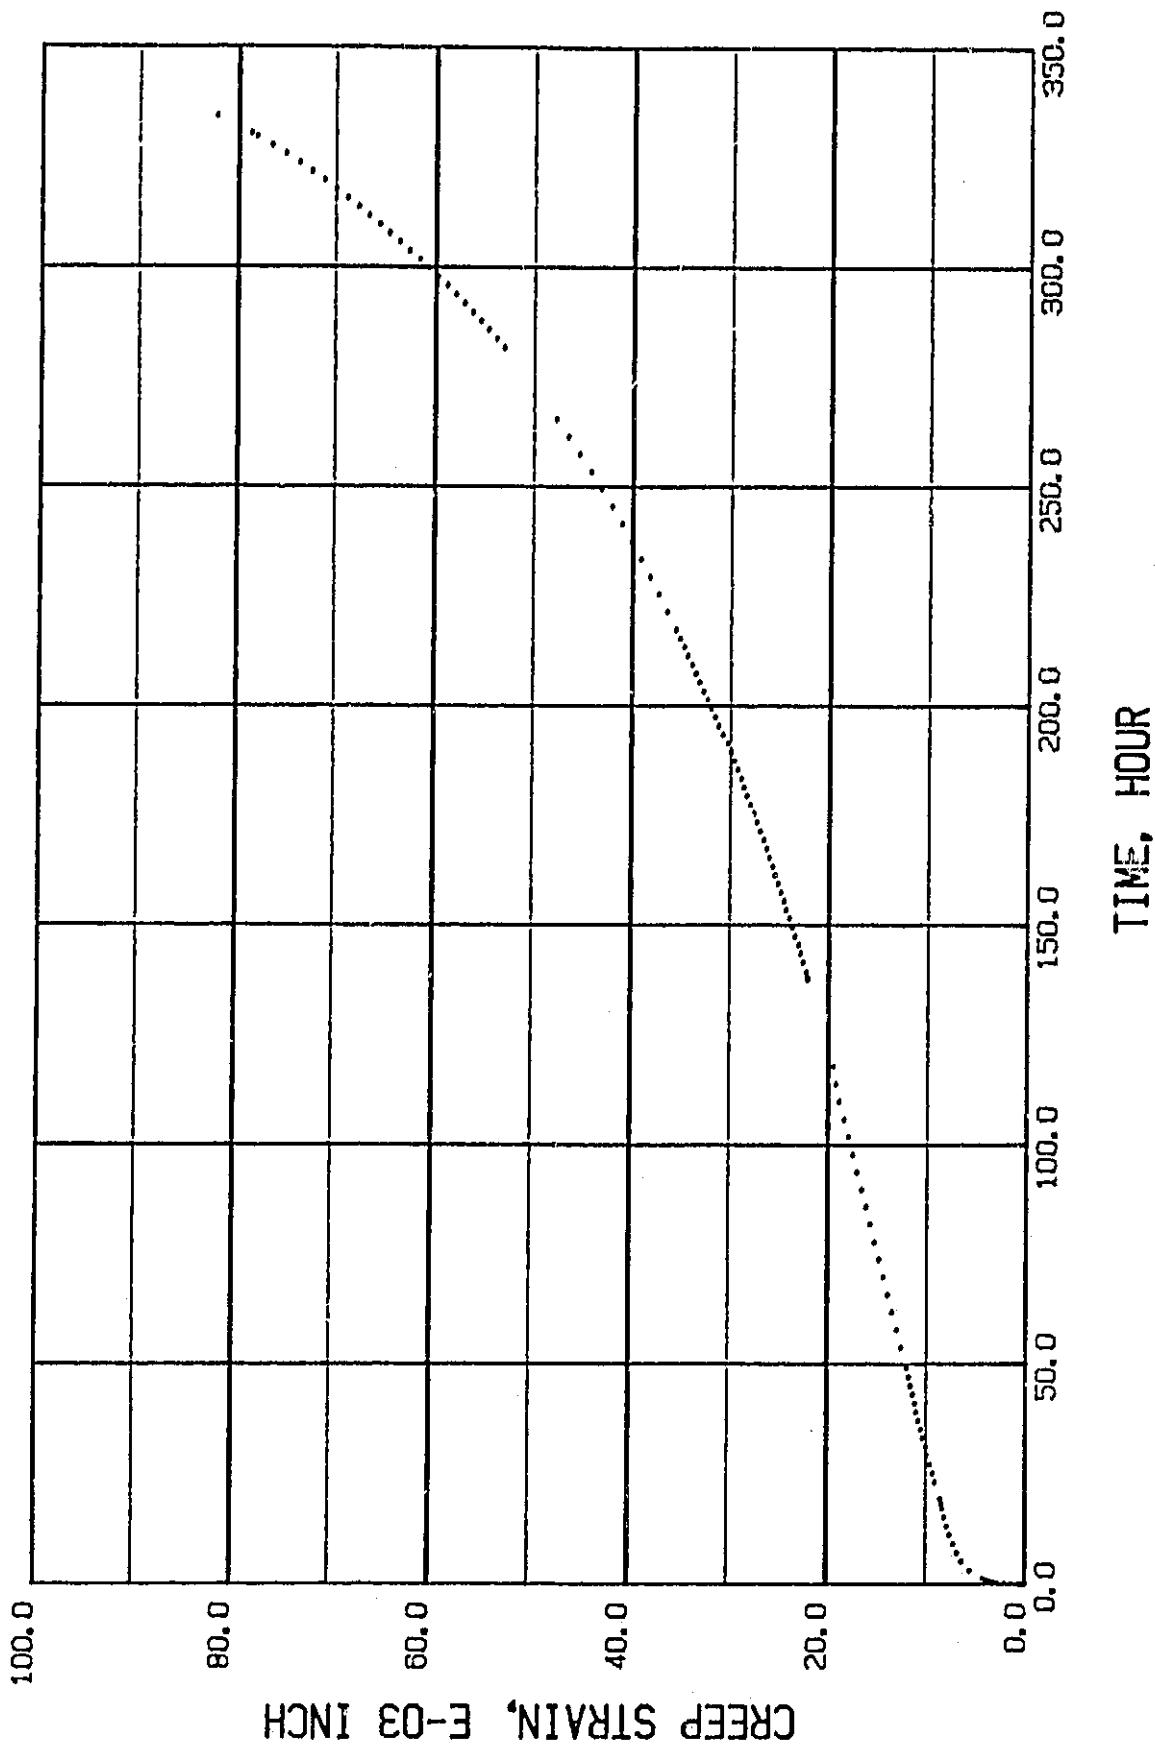
TEST H13 SA-F11 760C./260MPa 15 MPa H₂

Figure 12. Creep strain-time curve for SA-F11 tested at 760°C in 15 MPa H₂ (rupture life, 336 h).

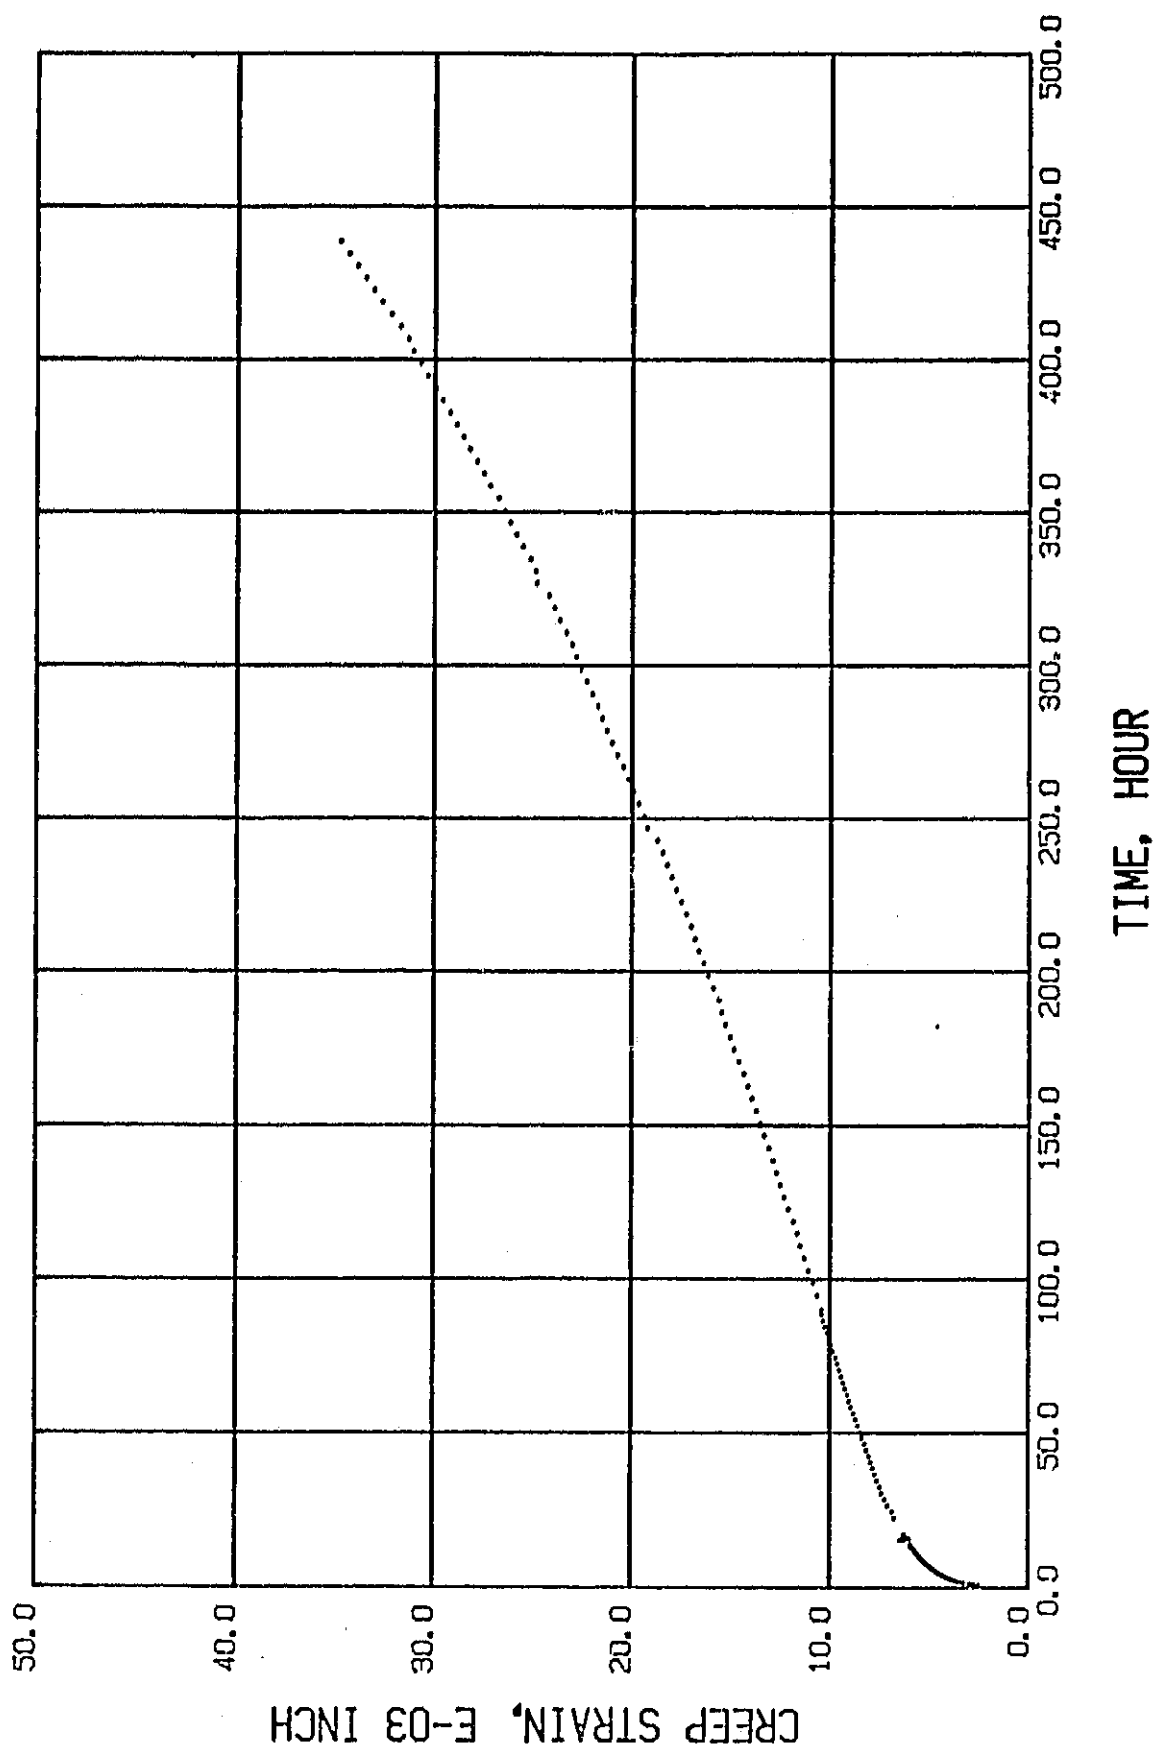
TEST H14 SA-F11 760C./230MPa 15MPa H2

Figure 13. Creep strain-time curve for SA-F11 tested at 760°C in 15 MPa H₂ (test continuing beyond 445 h).
